Pentium® II Xeon™ Processor Specification Update

Release Date: December 1998

Order Number: 243776-008

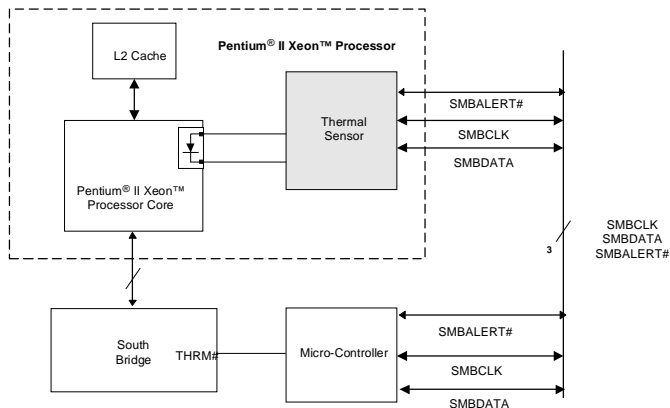
Figure 1. An Example of Microcontroller Driven Thermal Management

D30. Thermal Sensor May Assert SMBALERT# Incorrectly

PROBLEM: The Pentium II Xeon processor has a thermal sensor that monitors the processor core's temperature. The thermal sensor asserts SMBALERT# if the processor temperature exceeds the temperature limits set in the Alarm Threshold Registers (T_{HIGH} , T_{LOW}). It also sets the corresponding Status Register bits to identify the cause of the interrupt. Figure 1 gives one example of the how the SMBALERT# signal could be used in a system.

Under the conditions described below, the thermal sensor incorrectly generates the SMBALERT# interrupt. *All* of the following conditions must be met to trigger a false interrupt:

WORKAROUND: Three different (mutually exclusive) workarounds are possible:

1. Before servicing an interrupt from the thermal sensor, read and compare the processor thermal reading with the threshold limits (T_{HIGH} or T_{LOW}). Figures 2 and 3 provide basic flowcharts for the implementation of this workaround in an interrupt driven system.
2. If the firmware implemented polls the Status Register only, then before taking any action, re-read the temperature register and do a comparison with the alarm threshold limits (T_{HIGH} or T_{LOW}) to determine if the value is actually still within the temperature window.
3. Use a temperature polling scheme to monitor the processor temperature.
